# Ancient Machu Picchu Drainage Engineering

**Kenneth R. Wright**

**ABSTRACT:** The drainage infrastructure constructed by the Inca at ancient Machu Picchu represents a significant public works achievement. The difficult site constraints associated with the nearly 2,000 mm per year of rainfall, steep slopes, landslides, and inaccessibility posed drainage challenges that were met successfully by the Inca. The technical analysis of the Inca drainage works demonstrates that the drainage criteria used were reasonable and the implementation exceptional, and that the Inca were good engineers even though they labored without the benefit of a written language or the use of a wheel. Proof of the Inca success with drainage rests with the fact that Machu Picchu lay in the rainforest for 400 years without failure. There is no better example of successful ancient civil engineering than Machu Picchu. It was built by Native Americans before the arrival of the Spanish Conquistadors, was essentially abandoned in 1540 A.D., and endured for 4 1/2 centuries under a thick rainforest until the 20th century. Scientists, engineers, and laymen alike continue to marvel at the wonders of Machu Picchu.

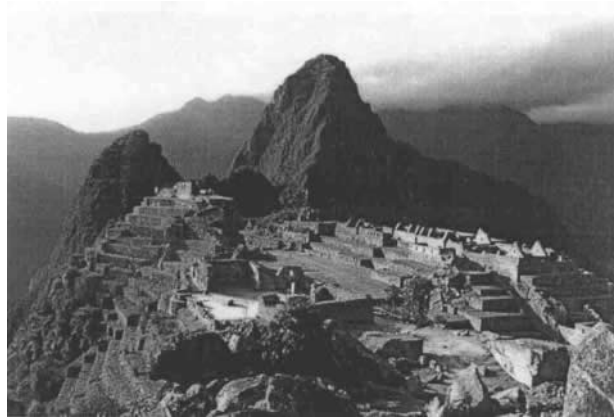
*Figure 1. Machu Picchu Was in Good Condition after Four Centuries of Rain Forest Growth When Discovered by Yale Explorer Hiram Bingham in 1911. Its Longevity and Resistance to Landslides and Settlement Are Result of Extensive Drainage Systems Built by Inca in 15th and 16th Centuries.*

When Professor Hiram Bingham returned to Yale University after his discovery of Machu Picchu, Peru, in 1911, he stated that "the Inca were good engineers" (Bingham 1913). Recent engineering research at Machu Picchu has demonstrated that Bingham was correct. This paper describes the carefully planned and constructed drainage infrastructure at Machu Picchu, without which it would not have endured to the present (Fig. 1).

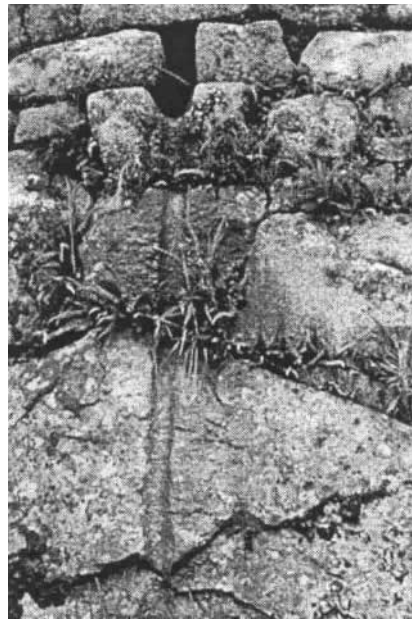
*Figure 10. Engineers Strategically Placed 129 Surface Drainage Outlets in Walls to Drain Interior Ground Surfaces. This Drainage Outlet Was Fitted with Vertical Channel to Avoid Splash.*

7. A well-conceived and strategically placed urban area system of 129 drain outlets placed in the numerous stone retaining and building walls (Fig. 10).
8. Subterranean caves strategically used for drainage discharge, with relatively free subsurface flow via natural underlying permeable deposits of granite rock falls.

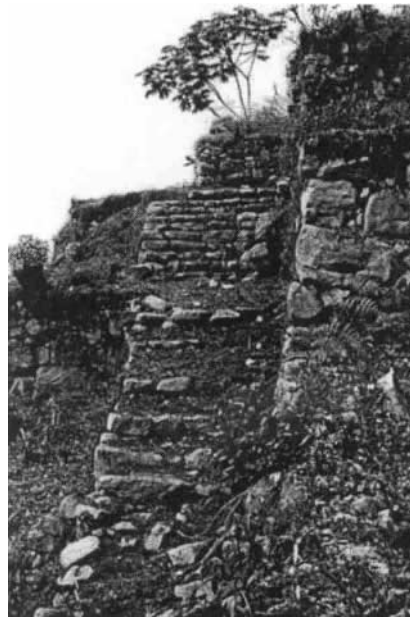
Figure 14. Main Inca Trail from Machu Picchu to Urubamba River Lying Adjacent to Fountains 3, 4, and 5 on Eastern Flank of Ridge.

The 1998 field exploration resulted in more than the excavation of the fountains: a previously unknown Inca trail was discovered. The trail is typically 2 m wide, with many excellent granite staircases ranging up to 3 m wide (Fig. 14). The Inca trail route was followed through the thick rainforest all the way down to the Urubamba River, where the ancient low water crossing was found. The trail is judged by the writers as being the primary trail from Machu Picchu to the easterly Vilcabamba region.
